# Operating Experience Weekly Summary 97-43

*October 17 through October 23, 1997*

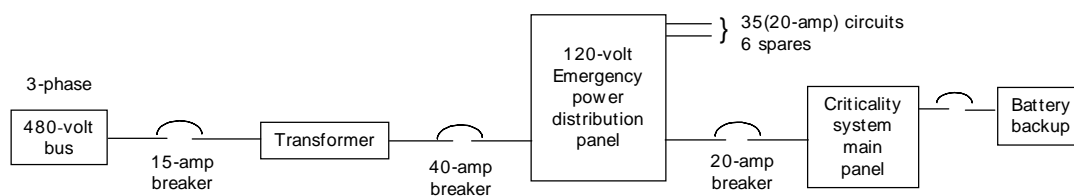
**Figure 1-1. Simplified Drawing of the Criticality System Main Panel Power Supply**

When maintenance personnel re-entered the building to troubleshoot the problem, they determined that the emergency power distribution panel supplying power to the criticality alarm system main panel was overloaded. They determined that non-essential loads, such as personal radios, coffee pots, and microwave ovens, were also being powered by the emergency power distribution panel. They removed all non-essential loads, marked the outlets out-of-service, and successfully reset the breaker.

This was the second loss of power to the main panel in two days. Maintenance personnel determined that shop and office electrical outlets were powered from the emergency power distribution panel, and some of them were not labeled as emergency power outlets. Because workers had plugged various electrical items into the outlets, the rated capacity of the transformer was exceeded, causing the supply breaker to trip. Figure 1-1 shows a simplified drawing of the criticality system main panel power supply.

The facility manager held a fact-finding meeting. He directed Maintenance to ensure that no personal items are plugged into outlets fed from the emergency power distribution panel. He also told them to install caution tags on the outlets indicating “emergency use only.” The following corrective actions to prevent recurrence will be implemented.

- A work package to locate and uniquely identify all outlets powered from the emergency power distribution panel will be developed.
- All non-emergency loads will be disconnected from the distribution panel.

- Non-emergency power will be provided to the shop and office areas.

- The power rating of the emergency power distribution panel supply transformer will be evaluated.
- The 15-amp supply breaker will be tested to ensure it does not trip below its setpoint.
- Other 120-volt emergency power distribution panels in the facility will be evaluated to ensure similar conditions do not exist.

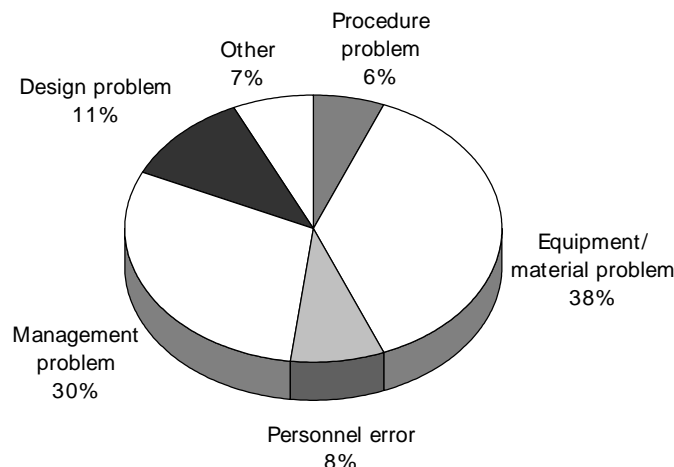
**Figure 1-2. Root Causes for Criticality Alarm Malfunctions<sup>1</sup>**

OEAF engineers searched the ORPS database for events involving criticality alarm malfunctions and found 286 occurrences. Figure 1-2 shows the root causes for these events. A review of these occurrences shows that DOE facility managers reported 38 percent of the root causes as equipment/material problems, with 80 percent attributed to defective or failed parts. In addition, 30 percent of the root causes were reported as management problems, with 32 percent attributed to inadequate administrative control and 26 percent attributed to work organization/planning deficiencies.

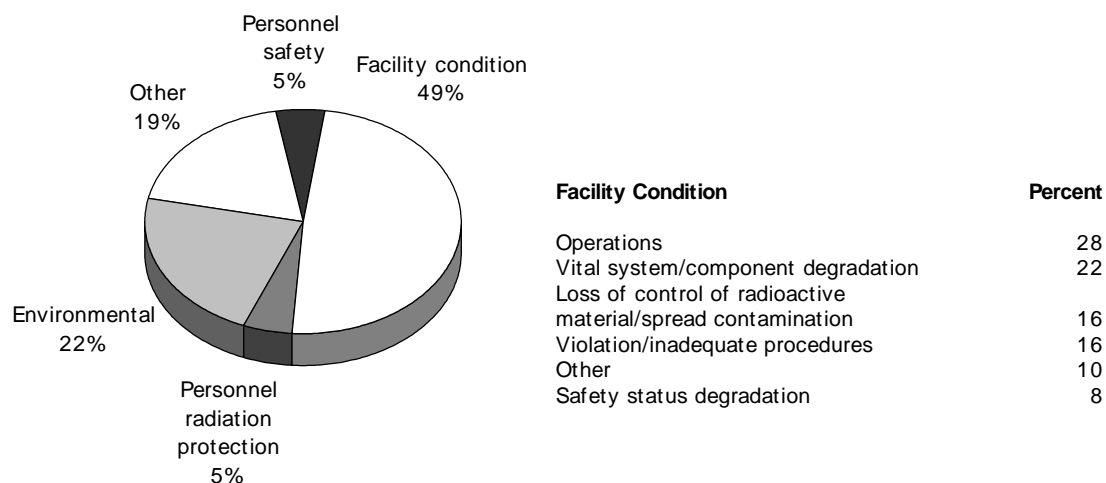
### Figure 2-1. Nature of Occurrences for Lack of Procedure Events<sup>1</sup>

OEAF engineers searched the ORPS database for events with a root cause of lack of procedure and found 693 events, with 762 nature of occurrences. Figure 2-1 shows the nature of occurrences for these events. A review of these occurrences shows that 49 percent of the events affected the facility condition, with 22 percent attributed to vital system/component degradation. In addition, 22 percent of the events that affected the facility condition were reported as environmental, with 40 percent resulting in hazardous substance releases and an additional 21 percent involving radionuclide releases.

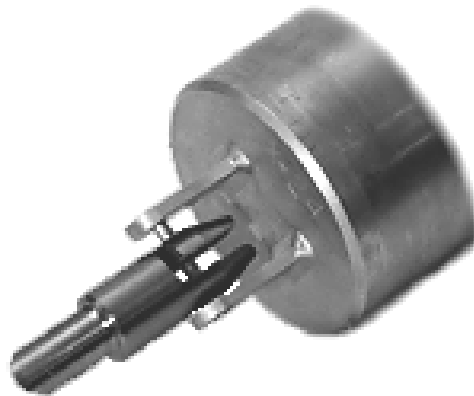
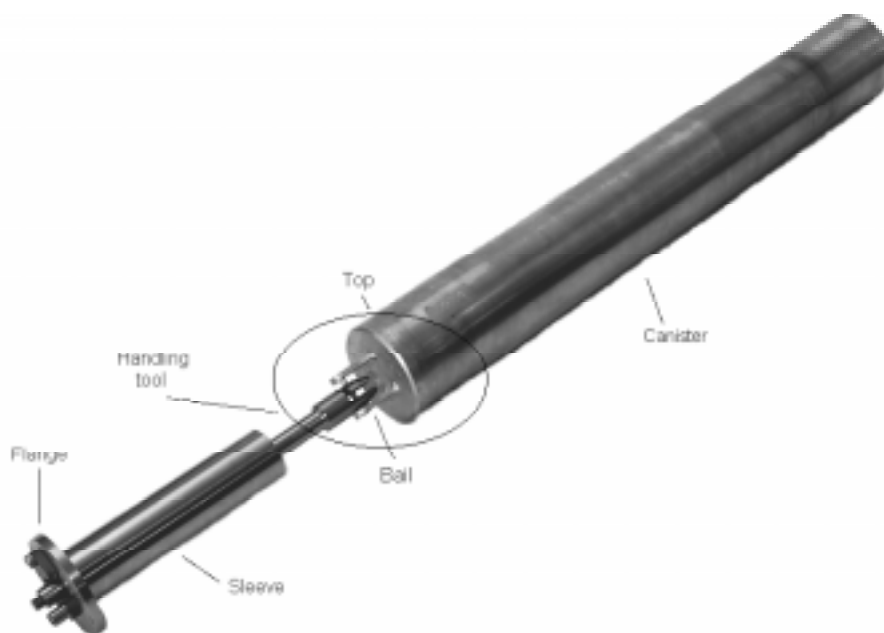
**Figure 4-1. Handling Tool and Canister**

The spent fuel was double-encapsulated in the aluminum canister. At the time of the disengagement, fuel handlers were attempting to lower the canister out through the bottom of the cask using the handling tool. The canister is attached to the tool, and the tool is locked to a flange that attaches to the top of the cask. Fuel handlers attach a wire rope to the threaded end of the handling tool, release the locking pin that secures the tool to the flange, and lower the canister out of the cask. During this evolution the wire rope went slack, indicating that the canister may have hung up. When the handlers attempted to re-close the opening in the bottom of the cask, the canister fell out to the hot-cell floor below.

Figure 4-1 shows the handling tool attached to the bail on the top of the canister. The canister bail slides into a slot in the tool, and the tool is rotated 90 degrees. The bail sits in a recess in the handling tool and is held in place by the weight of the canister. The tool is housed inside a sleeve and attached to the flange by a locking pin. The flange mates with the top of the bottom-loading cask. A planned corrective action is to replace the handling tool with one that is hollow with a rod inside that will block (close off) the opening once the tool is engaged. This will provide positive locking that will require deliberate action on the part of the fuel handlers to disengage the canister.
